MARINE INVESTIGATION REPORT
M99C0005

GROUNDING AND HULL DAMAGE

THE BULK CARRIER "ALGONTARIO"
AT JOHNSON POINT, ST. MARYS RIVER, ONTARIO
5 APRIL 1999

Report Number M99C0005

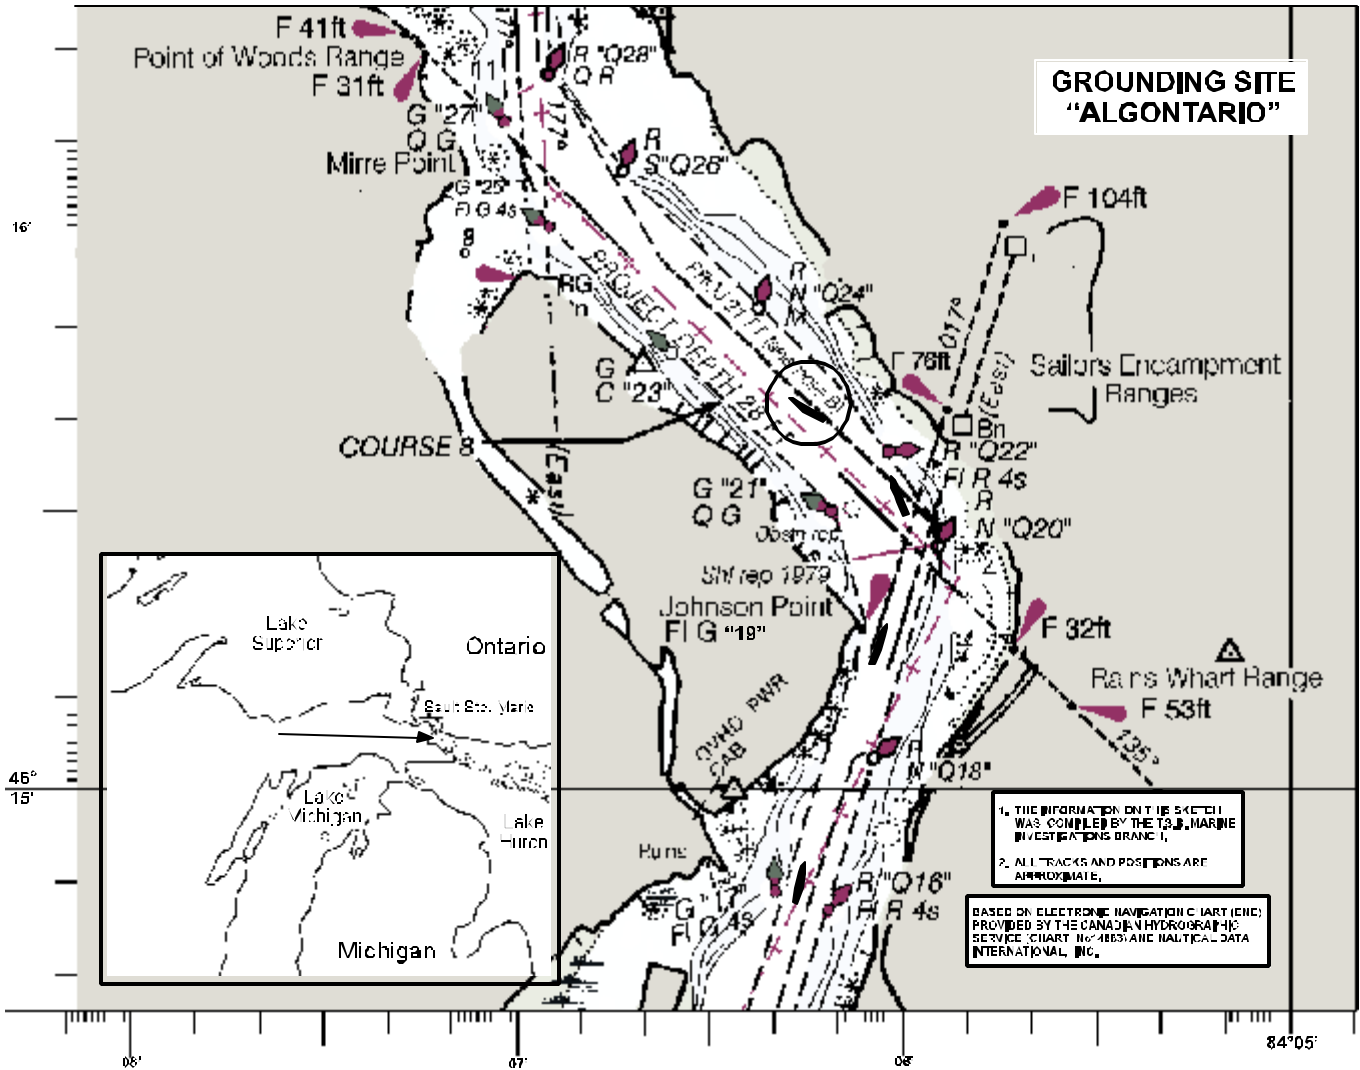
Appendix A - Occurrence Area with Track of the Vessel

There is conflicting information as to when the order to turn was given. Information retrieved from the ECDIS suggests that there is a discrepancy between the location where the order “Come to Port” was reportedly given and the position of the vessel when the bow started to swing to port. In fact, two thirds of the ship’s length had passed Johnson Point light when the first change of heading was recorded (see Appendix A).

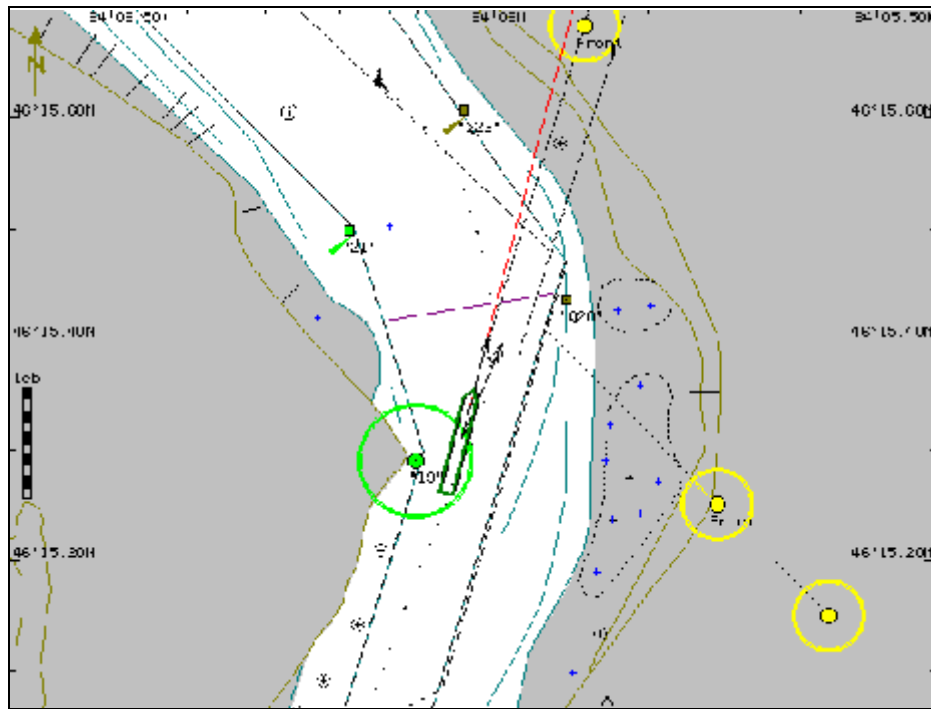
At 0434 the vessel passed buoy Q16 with an SOG of 7.5 knots. The helmsman steered the vessel using the Sailor's Encampment range lights, 017°T, using the left-hand-side range. At 0436 the speed had decreased to 7.4 knots at buoy Q18 and to 7.1 knots at 0438. At 0439, more than half the ship's length had passed Johnson Point light, which was approximately 60 m to port. The ship's heading was 015°T, and the SOG was 7.2 knots. The master called Soo Control at the winter calling-in point near Johnson Point. The mate noted the position in the log book. The engine speed was then increased to Position 6 on the throttle. At 0440, after the master ordered "Come to Port" when Johnson Point light was abreast of the bridge window, the helmsman immediately put the helm hard to port and the rudder angle indicator followed. The bow started to swing to port, as confirmed by an ECDIS heading of 354°T (see Appendix B, Figure 1).

Figure 1
Helm hard to port; wheelhouse abeam Johnson's Point Light

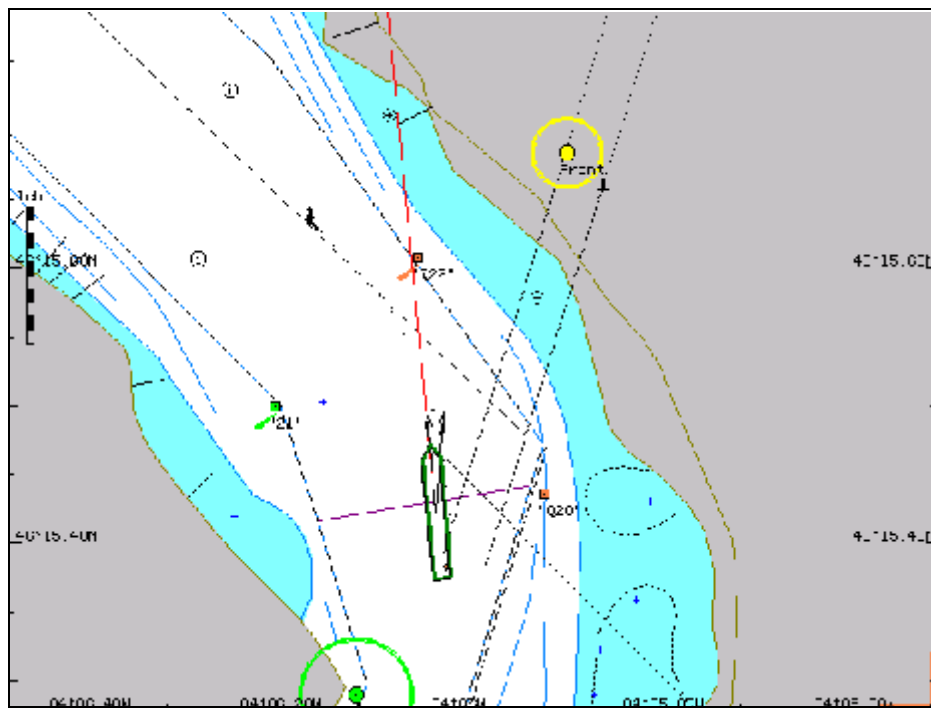
Johnson Point is a winter calling-in point. Normally, vessels make their report further south. The master made the report himself. He also used the spotlight to locate buoy Q22 in the darkness. These actions may have distracted the master from other navigation duties. The master did not ask the mate to assist him with the calling-in point report or to spot buoy Q22 at a critical alteration of course near Johnson Point.

Figure 2
Master monitors the turn; spot light on buoy Q22

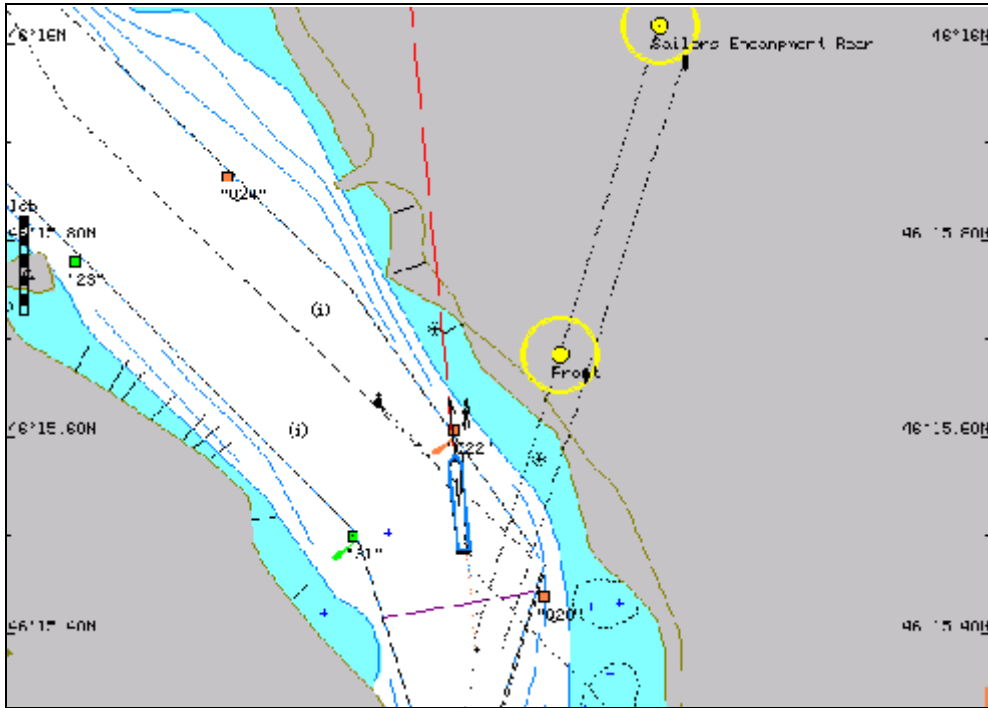
Figure 3
Throttle at Position 7; helm hard to port

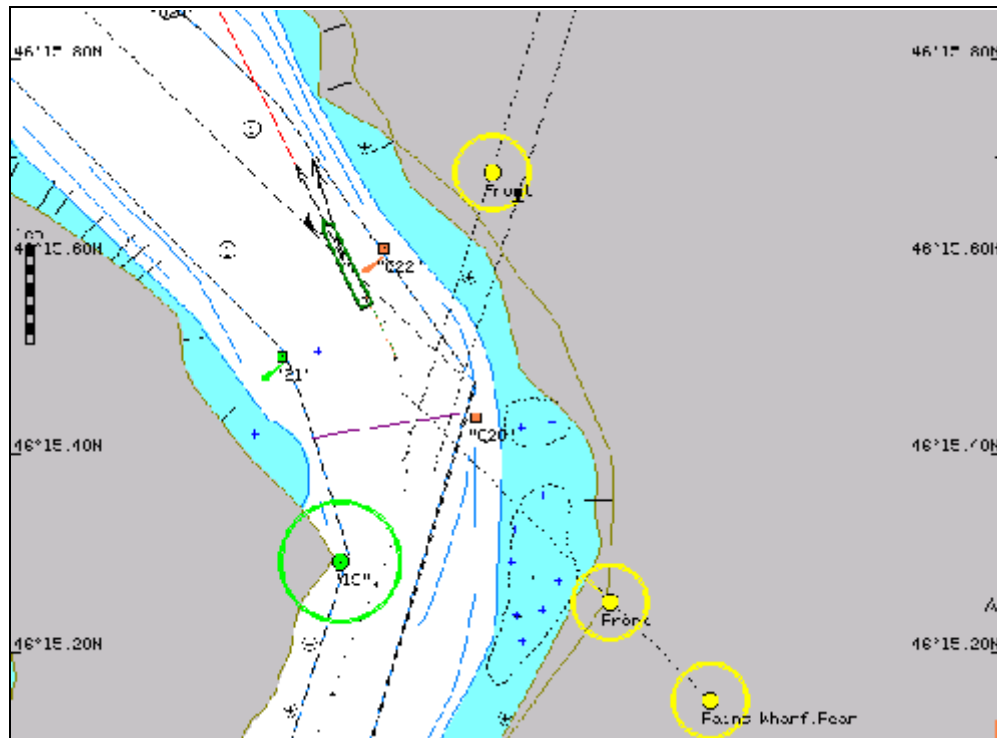
The vessel continued to turn to port but also drifted to starboard into the shallow channel. When the mate felt the vessel shudder, he left the chart table to go to the bridge front window. There was no reported discrepancy between ship time and ECDIS time (see Appendix B, Figures 4, 5, and 6).

Figure 4
Vessel strikes the 21 ft. edge of the channel; vessel shudders

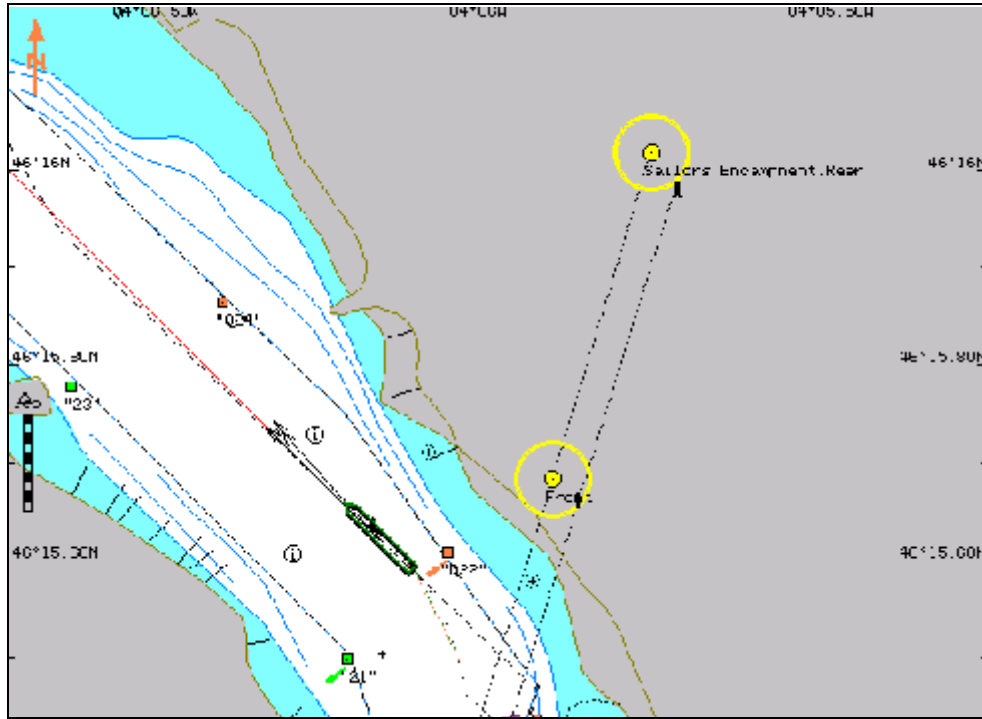
Figure 5
Vessel still making way; ship's bottom taking water

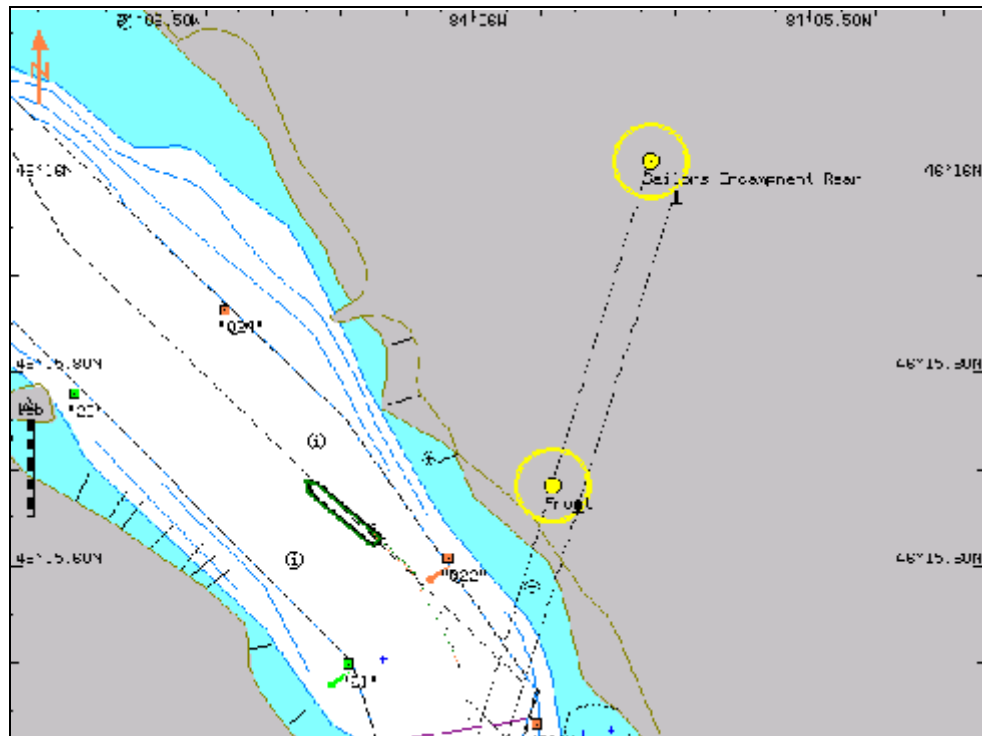
At 0443 the vessel grounded on a heading of 310°T in the 6.40 m (21 ft.) project depth section of the Middle Neebish Channel, 50 m on the Canadian side of the Canada–United States border, near buoys Q20 and Q22, in the following position: latitude 46°15.6' N, longitude 084°06.1' W.¹ The starboard side of the vessel was hard aground from No. 5 double bottom tank aft to the rudder skeg. The engine was stopped immediately. The ship came to rest with a three-degree starboard list. The grounding took place where Course 9 and Course 8 intersect in the upbound channel.

Figure 6
"ALGONTARIO" hard aground; on 21-foot Project Depth Course 8
